# ENVIRONMENTAL PROTECTION AGENCY

## Situation Report (SITREP) (2)

Location of incident: **7°18'08.68"N 151°53'36.61"E (WWII Vessel/Rio De Janeiro Maru)**

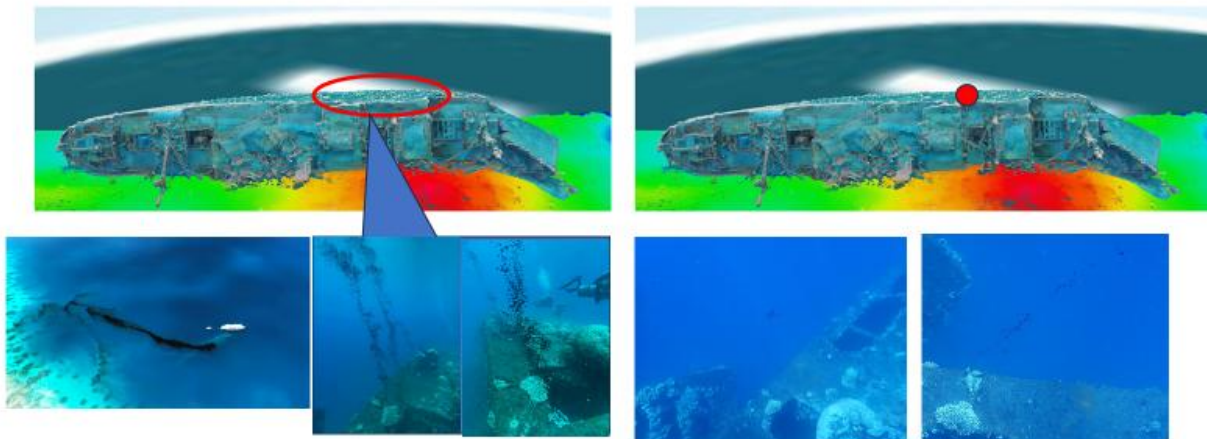
油漏れ箇所  
Oil leak location

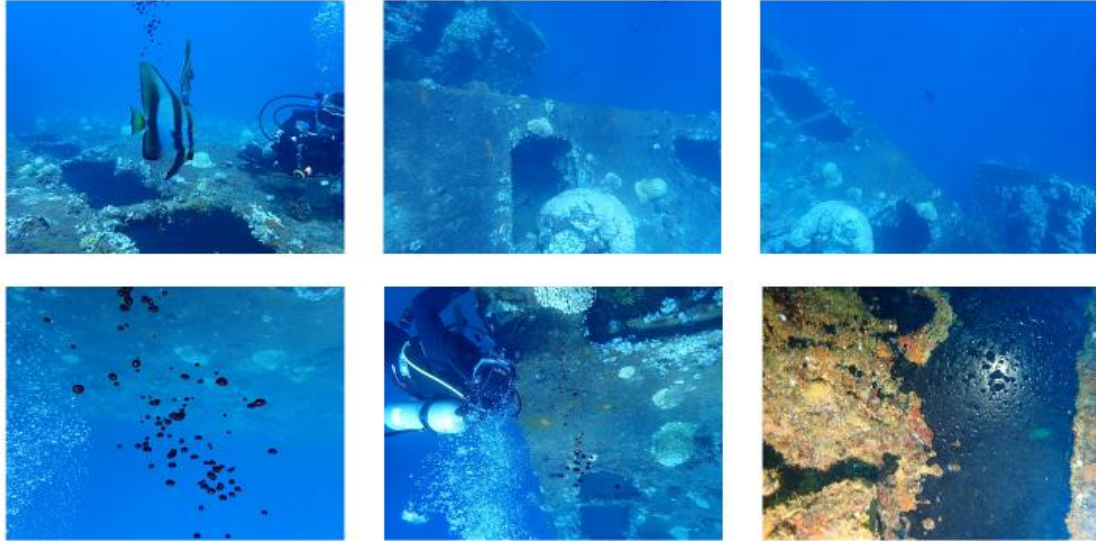
参考写真 (9. 15)  
Reference photo

- (3). Probable Cause
  - Since the oil leak was from the fuel tank's air vent pipe, and the hull diagram of the Ri Maru indicates that the fuel tank in question was likely the forward fuel tank, the probable cause is as follows:
    - (1) Difference in specific gravity between oil and water
    - Fuel oil has a lighter specific gravity than seawater, so when seawater enters the tank, the lighter oil is forced upward and discharged through the vent pipe.
    - (2) Discharge of oil due to external pressure
    - If the tank is partially collapsed or seawater flows in due to external water pressure, the pressure difference may cause the oil in the tank to be forced out through the vent pipe.
- (4) Change in hull position

Oil may have leaked via the fuel tank's air vent pipe.

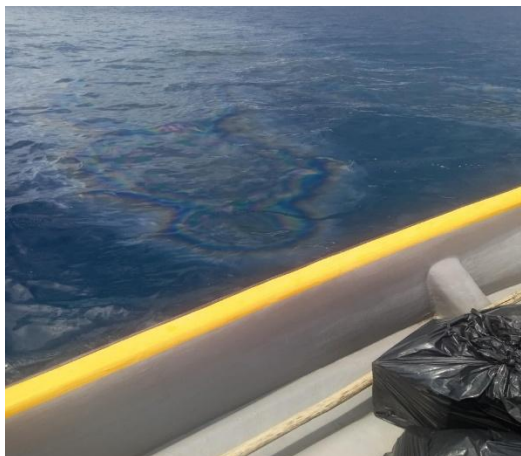
Oil leakage still occurring at the sunken vessel.

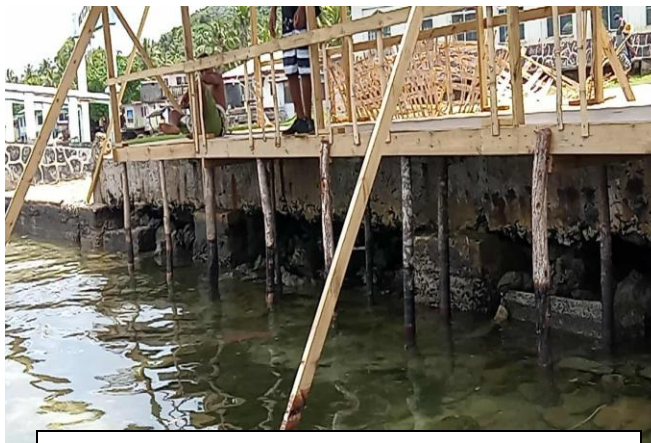
Sticky oil on structures along the shoreline.

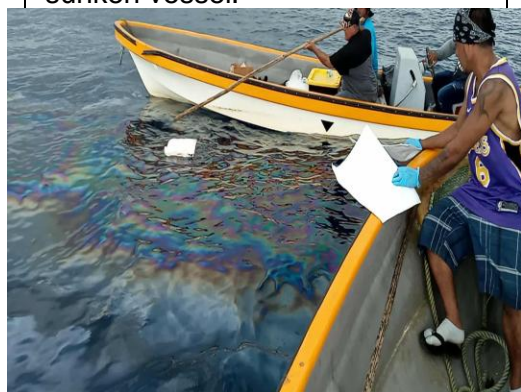
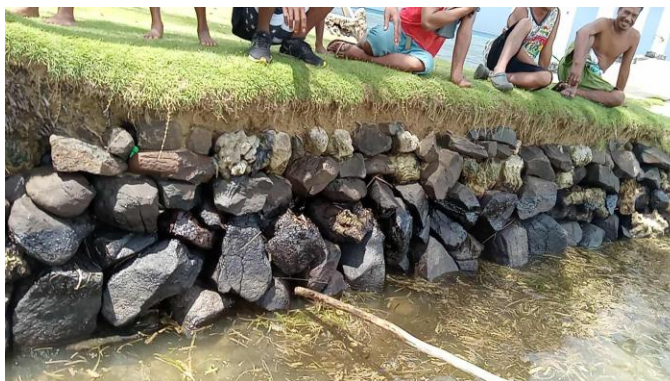
Sticky oil stuck on seawall.
