# ENVIRONMENTAL PROTECTION AGENCY

## Situation Report (SITREP) (3)

Location of incident: **7°18'08.68"N 151°53'36.61"E (WWII Vessel/Rio De Janeiro Maru)**

**Incident:** A significant marine oil spill from Rio De Janeiro leaked into/onto Uman Island and potentially on nearby islands.

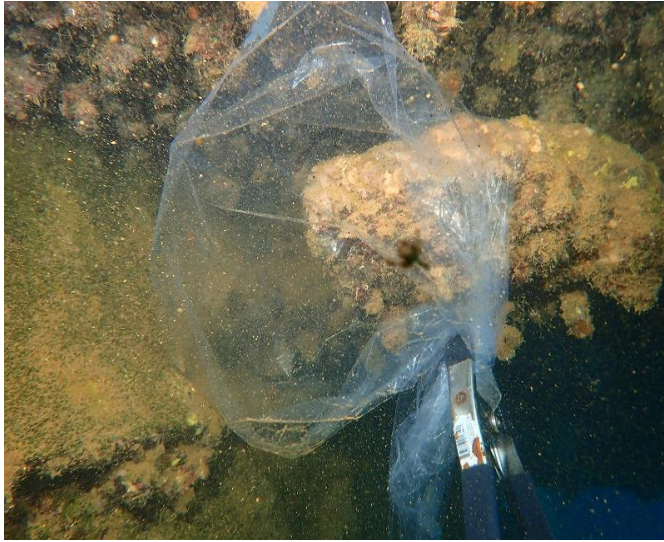
- Oil coating still visible on boats and docks
- Around Rio De Janeiro Maru's Hull: the leakage from the vent pipes confirmed was minimal. Plastic bags were placed over the two vent pipes to collect and measure the small amount of oil leaking (approximately 200cc in 10 minutes)

Image 2: Plastic covering of vent to measure amount oil, approximately 200cc in 10 minutes.

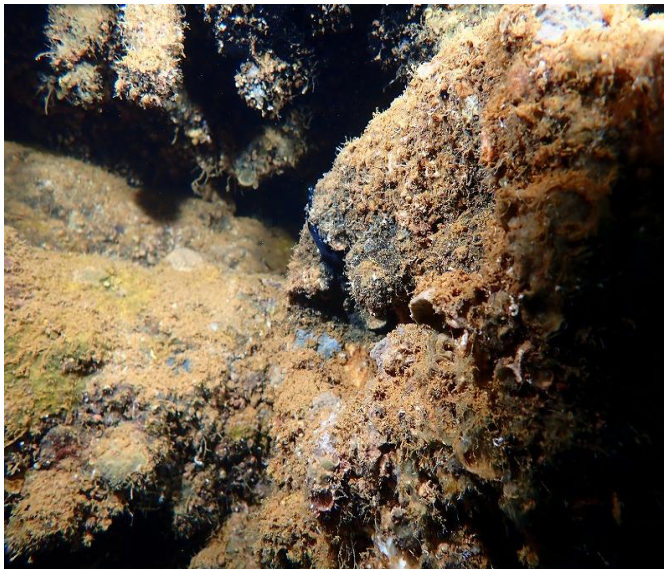
Image 3: Small leaks from tank

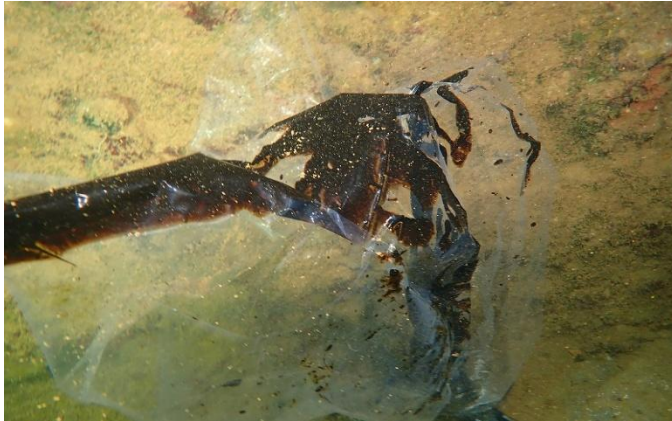
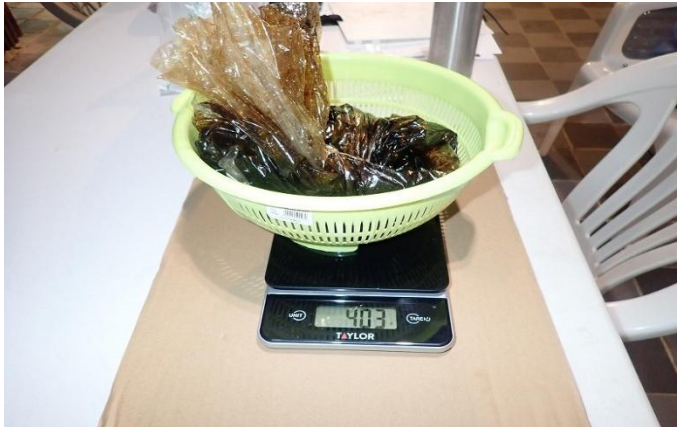
Image 4/5: Oil collected 326 grams within 10 minutes.

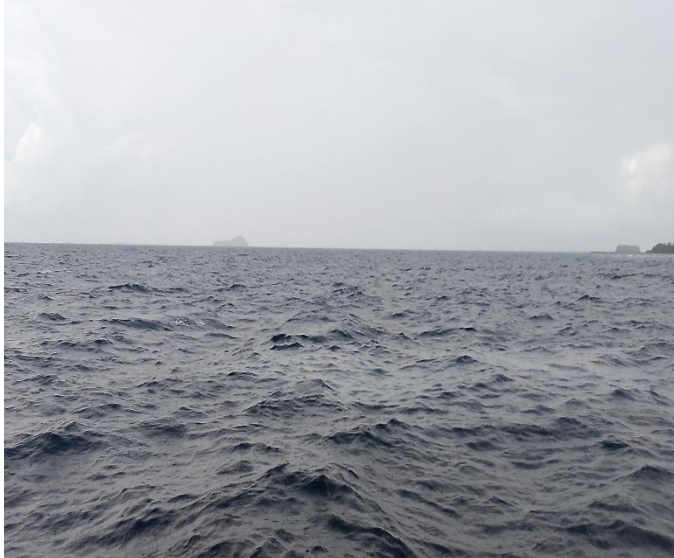
- Upon arrival to scene, weather was rough with rain (E winds, 12mph, 3-4ft wave height) blowing towards Uman Island
- a thin oil slick was visible on the sea surface drifting towards Uman

Image 6: Rainbow sheen, light thin oil moving towards Uman Island

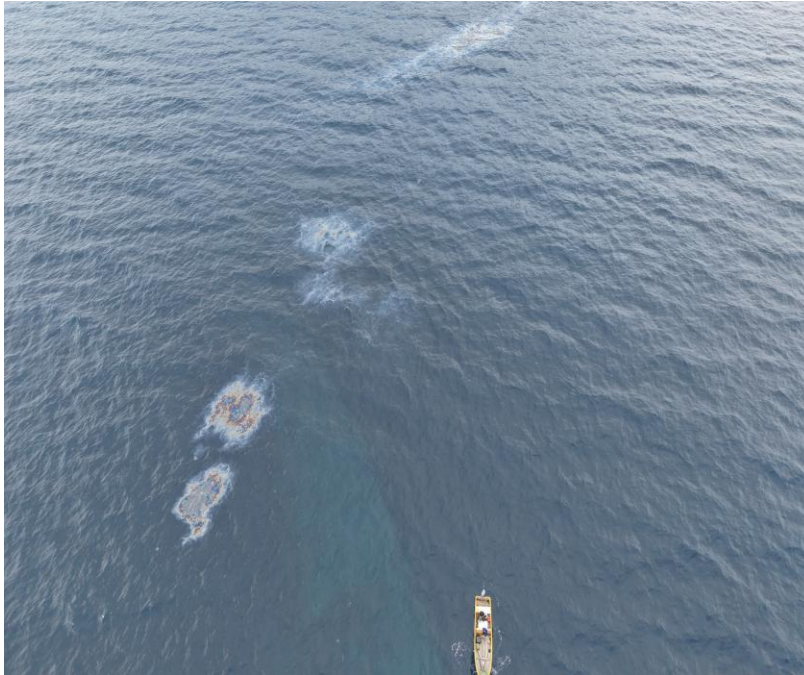
Image 7: 2 observed points of discharge/ Confirmed lubricant oil tank

- Suggested method for the capture, collection, concentration and offloading oil escaping from sunken wreck.
- Proposed IDA with affected villages

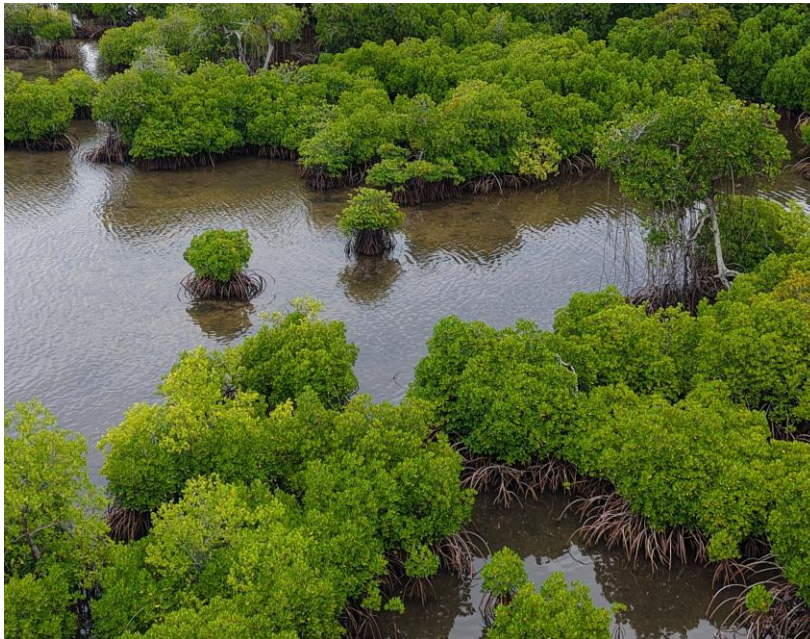
Image 8: Intact mangrove vegetation
