DEPARTMENT OF ENVIRONMENT, CLIMATE CHANGE AND EMERGENCY MANAGEMENT

# Building Resilience to Disaster and Climate Risks

# Federated States of Micronesia - Yap Outer Islands 2017

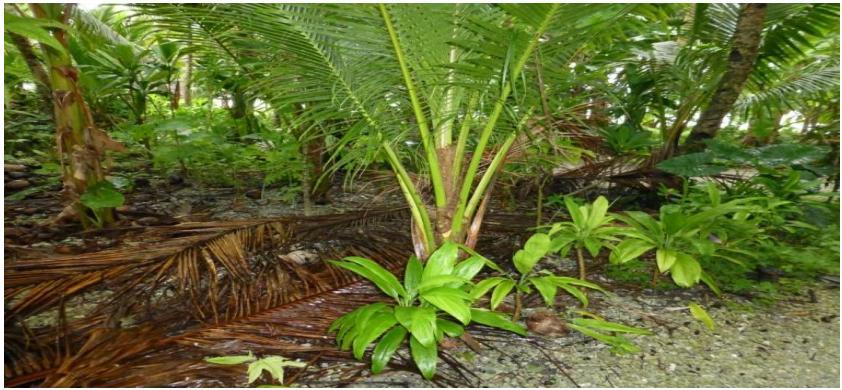
The pictures below showed how the crops are fairing in the outer islands of Yap. Despite the challenges posed, some crops did well as shown in the **Figure 1** and **Figure 2** below.

Figure 1. Photo of Coconut from the CRP

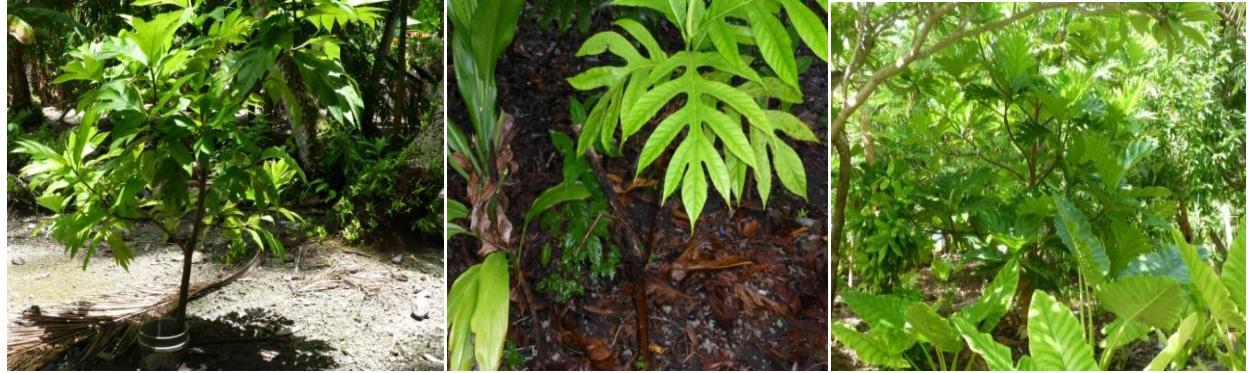
Figure 2. Photos of Samoan Breadfruit varieties from CRP distributed in October 2016

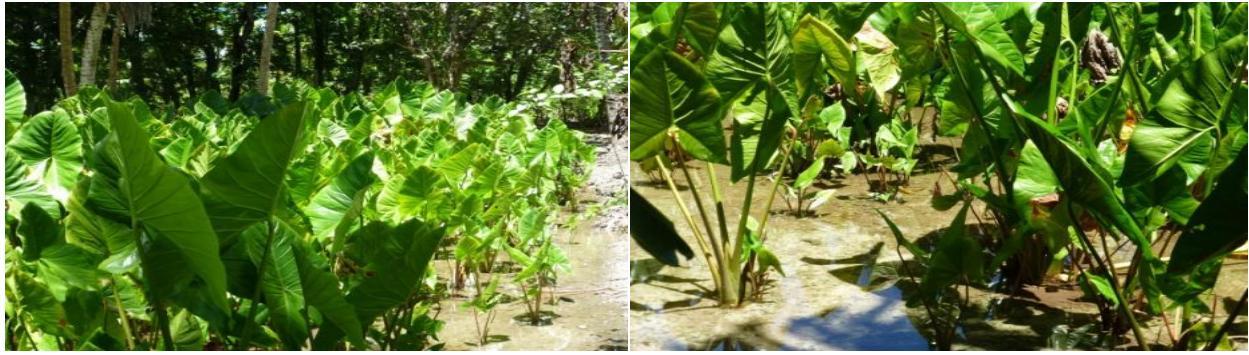
One of the main food securities that are known in the outer islands is taro. Some of the initiatives under the CRP were to address inundation affecting the taro patches. Some of the challenges faced are impacts of disaster and climate change. As shown in **Figure 3**, some of the taro patches are inundated by brackish water due to High/King Tides and Storm Surges. To address inundation, some of the islands have artificial taro patches build inland. However, some of the islands are not utilizing their artificial taro patches as indicated in **Figure 4**, and some farms have not been maintained and elevated.

Figure 3. Photos of Inundated Taro Patches with Brackish Water

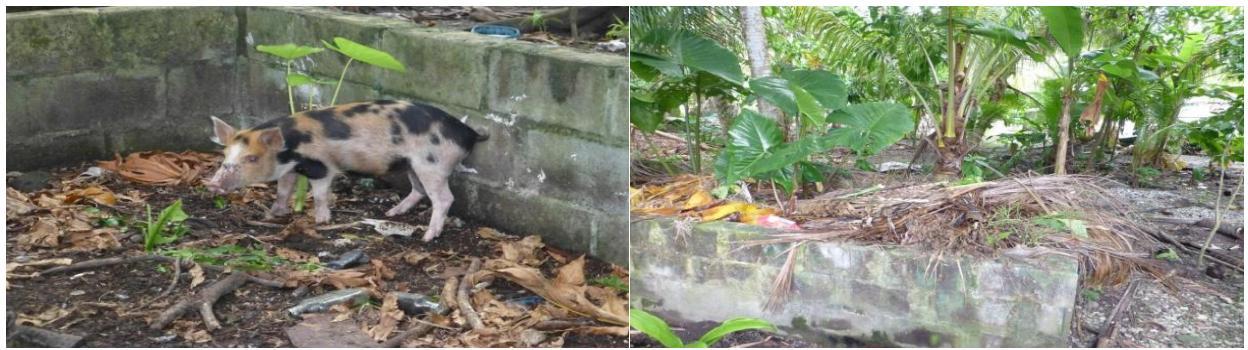
Figure 4. Photos of Artificial Taro Patches not Unitized

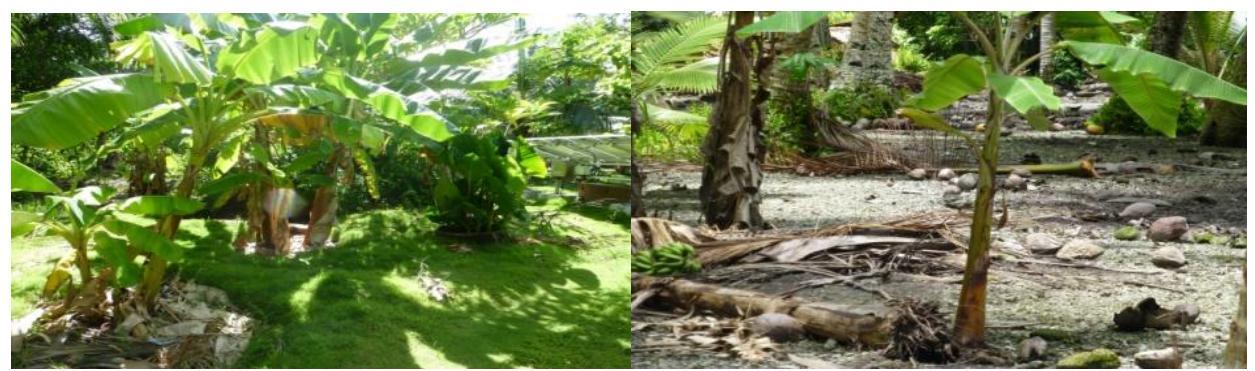
In addition to artificial taro patches, composting is another method used for planting. The method is used especially for banana trees. It enables a banana tree to bear shoots to grow healthier and reach maturity. It also protects a banana tree from falling when it matures. The **Figure 5** shows the banana trees with or without compost.

Figure 5. Photos of Banana with compost on left and without compost on right
