ENVIRONMENTAL PROTECTION AGENCY

Situation Report (SITREP) (4)

Location of incident: 7°18'08.68"N 151°53'36.61"E (WWII Vessel/Rio De Janeiro Maru)

Incident: A significant marine oil spill from Rio De Janeiro leaked into/onto Uman Island and potentially on nearby islands.

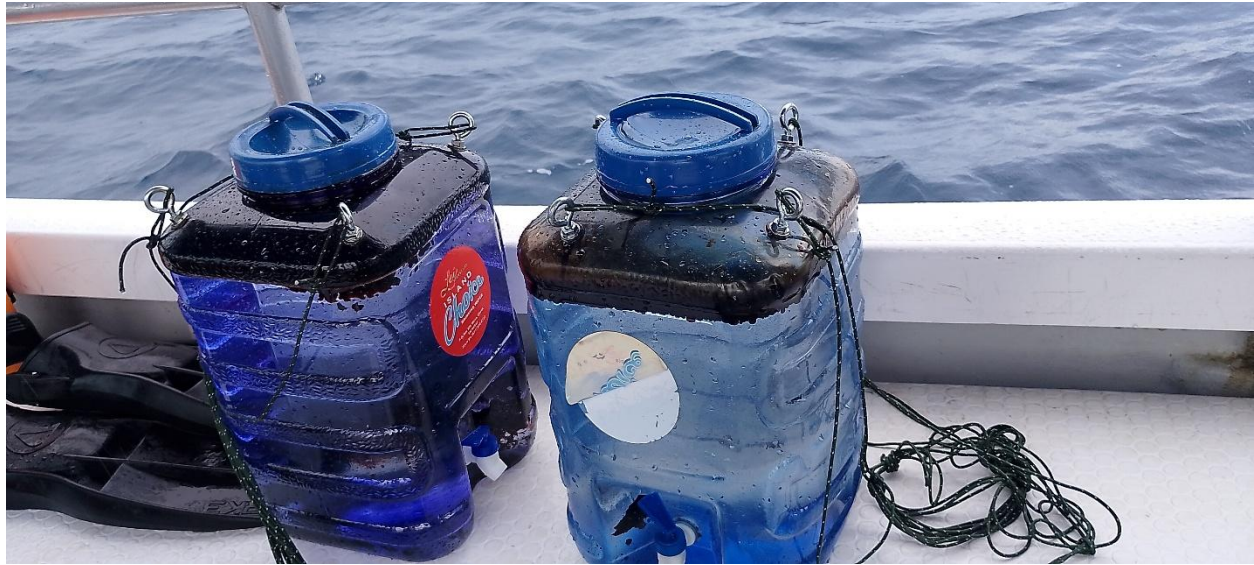
Photo 1: Make shift oil containment with results in 2 hrs.

- Installed makeshift oil collection containers at the two leak points and collected oil for 2 hours. As a result, the estimated amount of oil leaked was approximately 6.8L (1.7gals) per 24 hours. (Precise measurement scheduled for the 22nd)
- In 2 hours, oil was contained and no leakage on site

- **Confirmation with taskforce members on options to:**
 - Immediately and completely stop the leak
 - Temporary containment method until the leak naturally subsides/ including periodic collection of oil accumulated in the containers beginning next week
