# ENVIRONMENTAL PROTECTION AGENCY

## Situation Report (SITREP) (2)

Location of incident: **7°18'08.68"N 151°53'36.61"E (WWII Vessel/Rio De Janeiro Maru)**

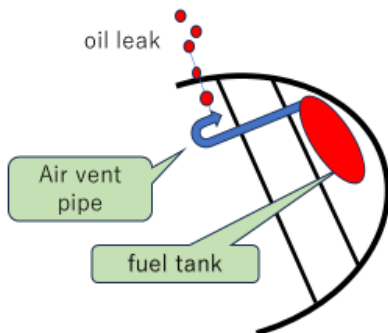
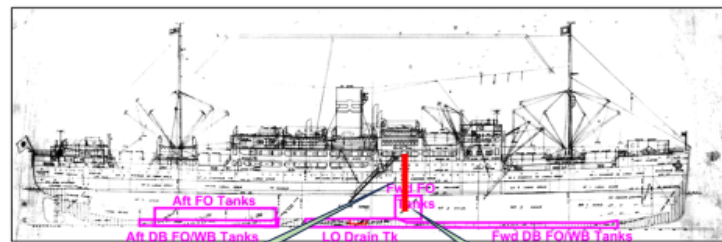
Oil may have leaked via the fuel tank's air vent pipe.

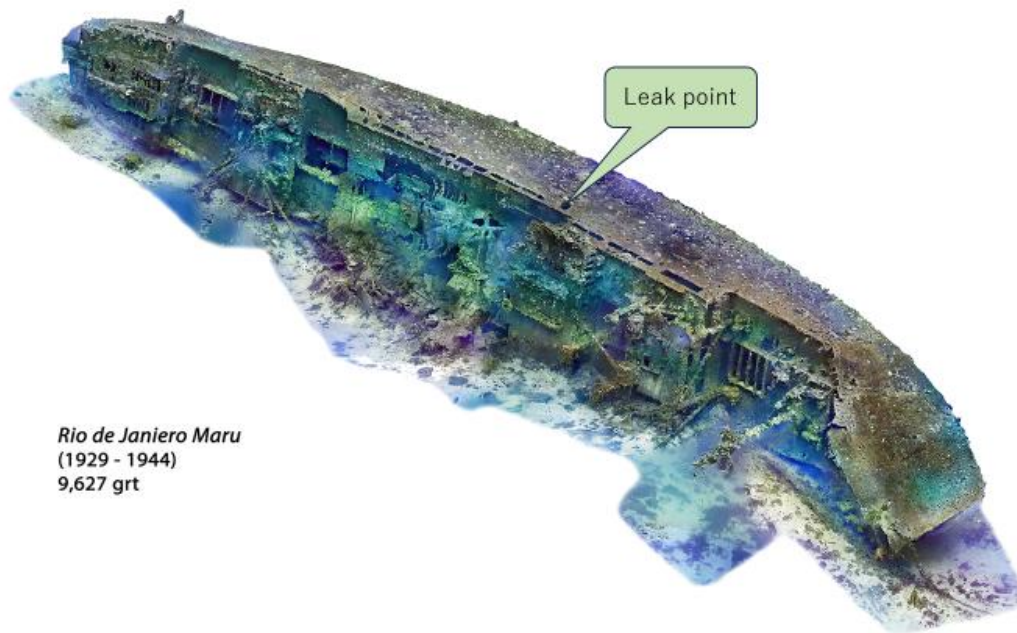
## タンクの配置 Tank location

- (3). Probable Cause
  - Since the oil leak was from the fuel tank's air vent pipe, and the hull diagram of the Ri Maru indicates that the fuel tank in question was likely the forward fuel tank, the probable cause is as follows:
    - (1) Difference in specific gravity between oil and water
    - Fuel oil has a lighter specific gravity than seawater, so when seawater enters the tank, the lighter oil is forced upward and discharged through the vent pipe.
    - (2) Discharge of oil due to external pressure
    - If the tank is partially collapsed or seawater flows in due to external water pressure, the pressure difference may cause the oil in the tank to be forced out through the vent pipe.
- (4) Change in hull position

*Rio de Janeiro Maru*  
(1929 - 1944)  
9,627 grt
