Kosrae Shoreline Management Plan

Repositioning for resilience

NIWA Client Report No: HAM2013-133
Report date: November 2013
NIWA Project: DGI13201

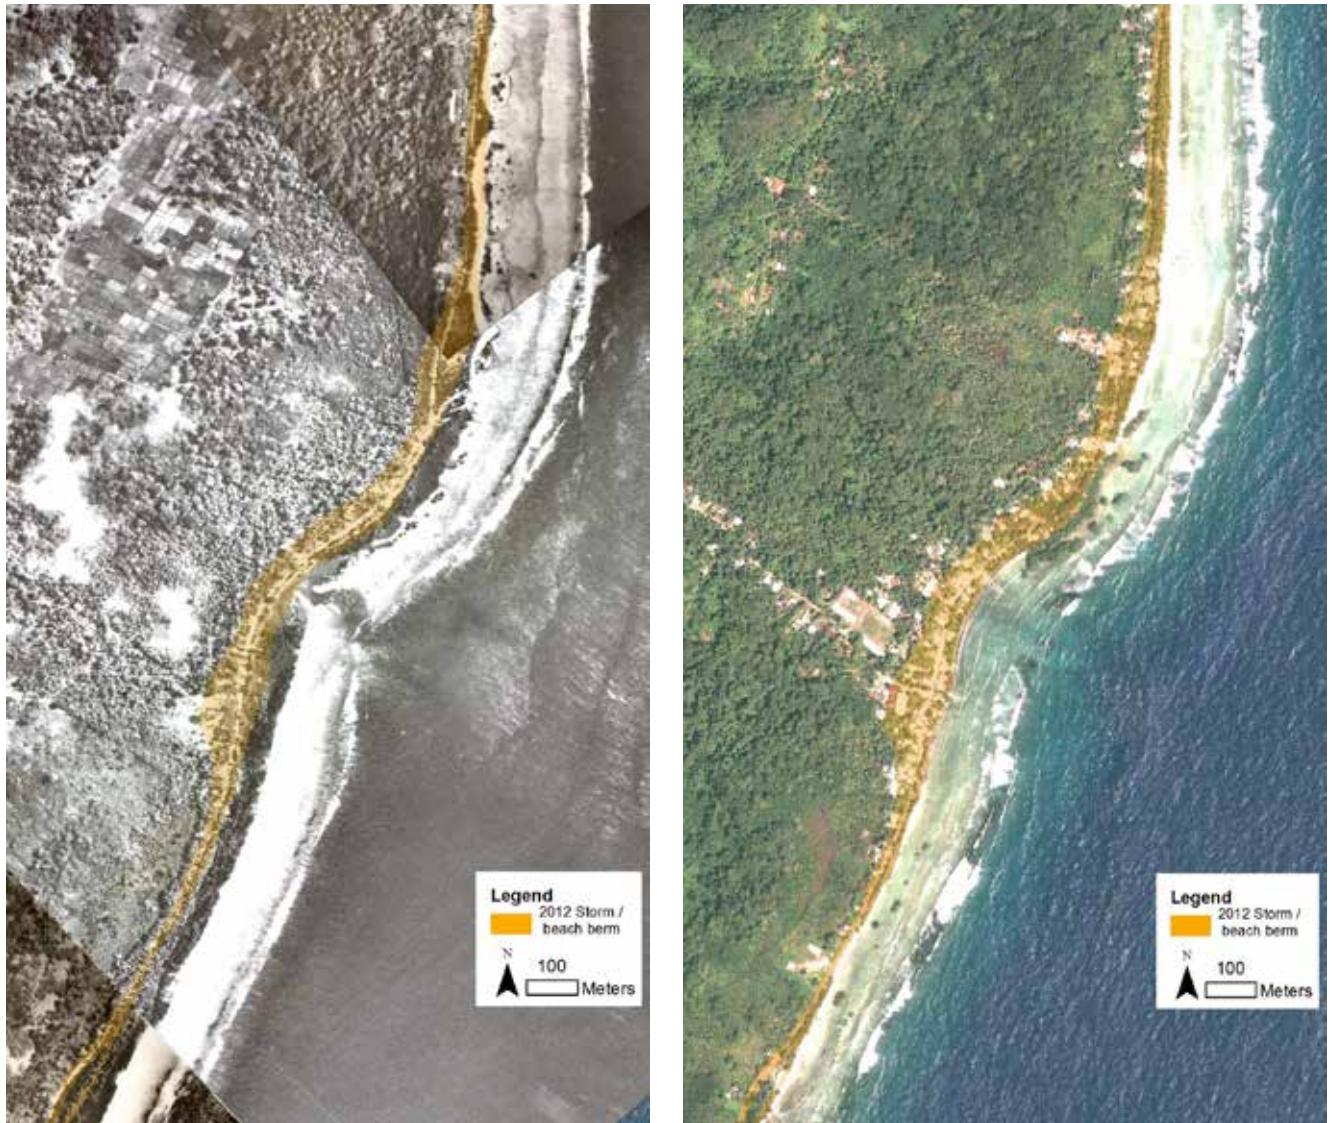
Figure 2: Development between 1944 and 2012 in Malem. Much of the development has taken place on the narrow storm berm between the shoreline and the low-lying wetlands.

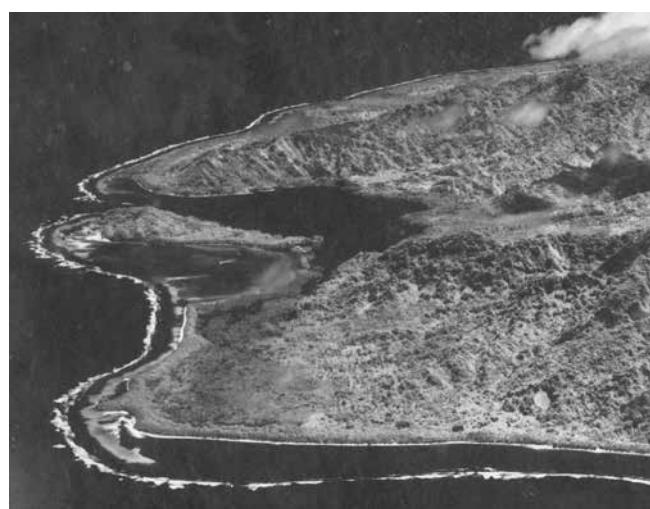
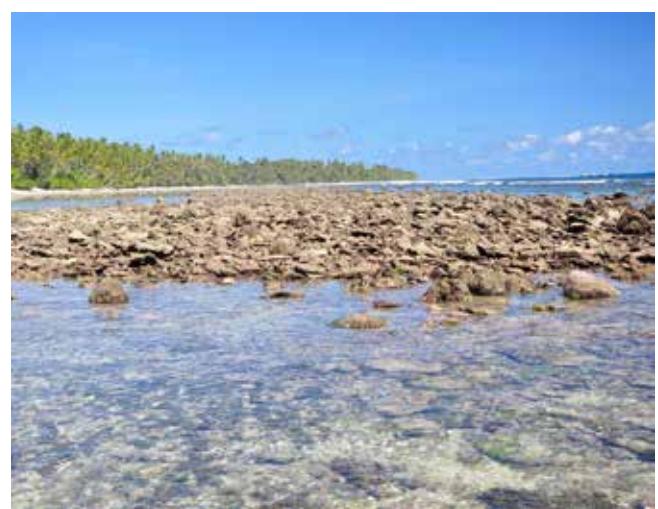
Figure 6: Aerial photograph of the north-east Kosrae coast in 1944 (left) and the remnants of the rubble ridge in 2013 at Putukte (right). The rubble ridge extending from Finaunpes all the way down the Pukusruk shoreline to Putukte can be clearly seen in 1944. The size of the ridge between Finaunpes and Finfokoa resulted in a build out of the shoreline in a bulge in the lee of the ridge. With the breakdown/removal of the rubble ridge, the sediment in this bulge in the shoreline has been redistributed along the adjacent coastline.

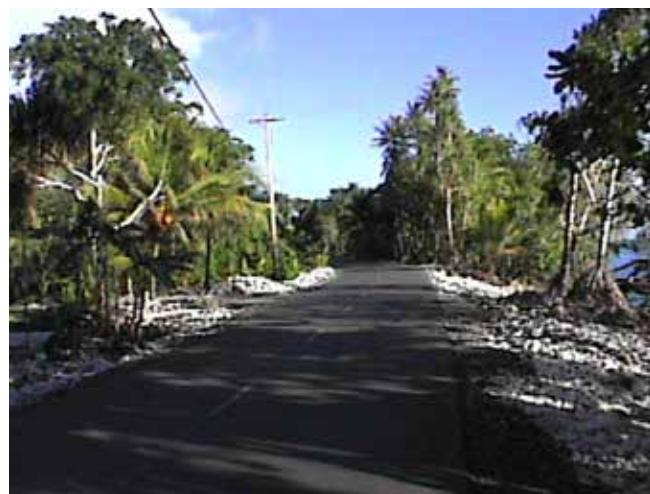
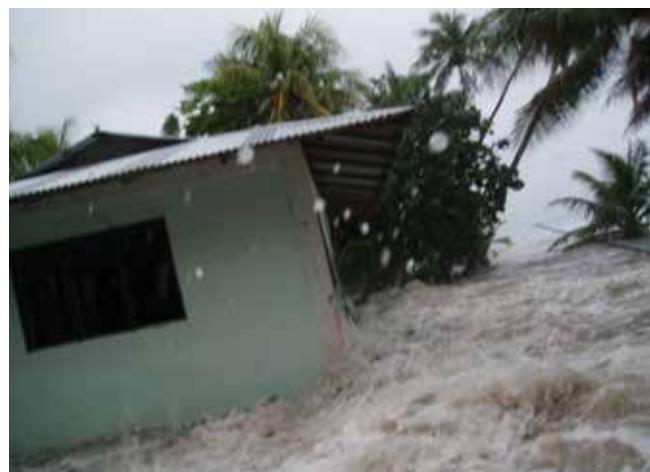
Figure 8: Overwashing of the road in South Malem during Tropical Storm 31W in December 2001 (top) and at Tafunsak during the December 2008 large swell event (bottom).

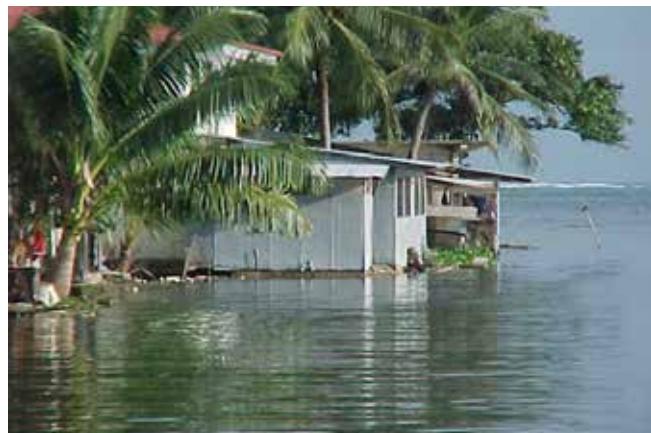
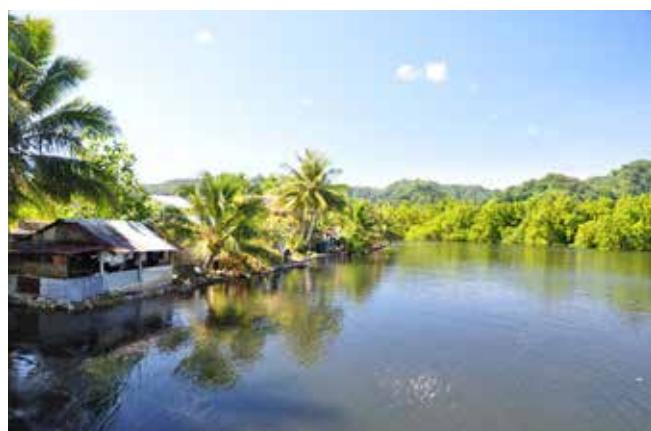
Figure 9: Low-lying reclaimed areas on Lelu Island (top) and Utwe village (bottom). Both Lelu and Utwe villages have been built on reclaimed land that is close to present day high spring tide levels. The frequency and severity of high-tide flooding will be an ever-increasing issue as sea-level rise continues. Constructing further seawalls will not prevent more frequently and severe inundation occurring in the future.

will result in increasingly more frequent damage to much of the infrastructure and property located along all parts of the coastal storm/beach berm and reclaimed areas (Figure 3). It will be increasingly difficult to maintain infrastructure and residential property located in these areas without substantial and continuous investment (for example raising reclaimed land levels in Lelu and Utwe villages).

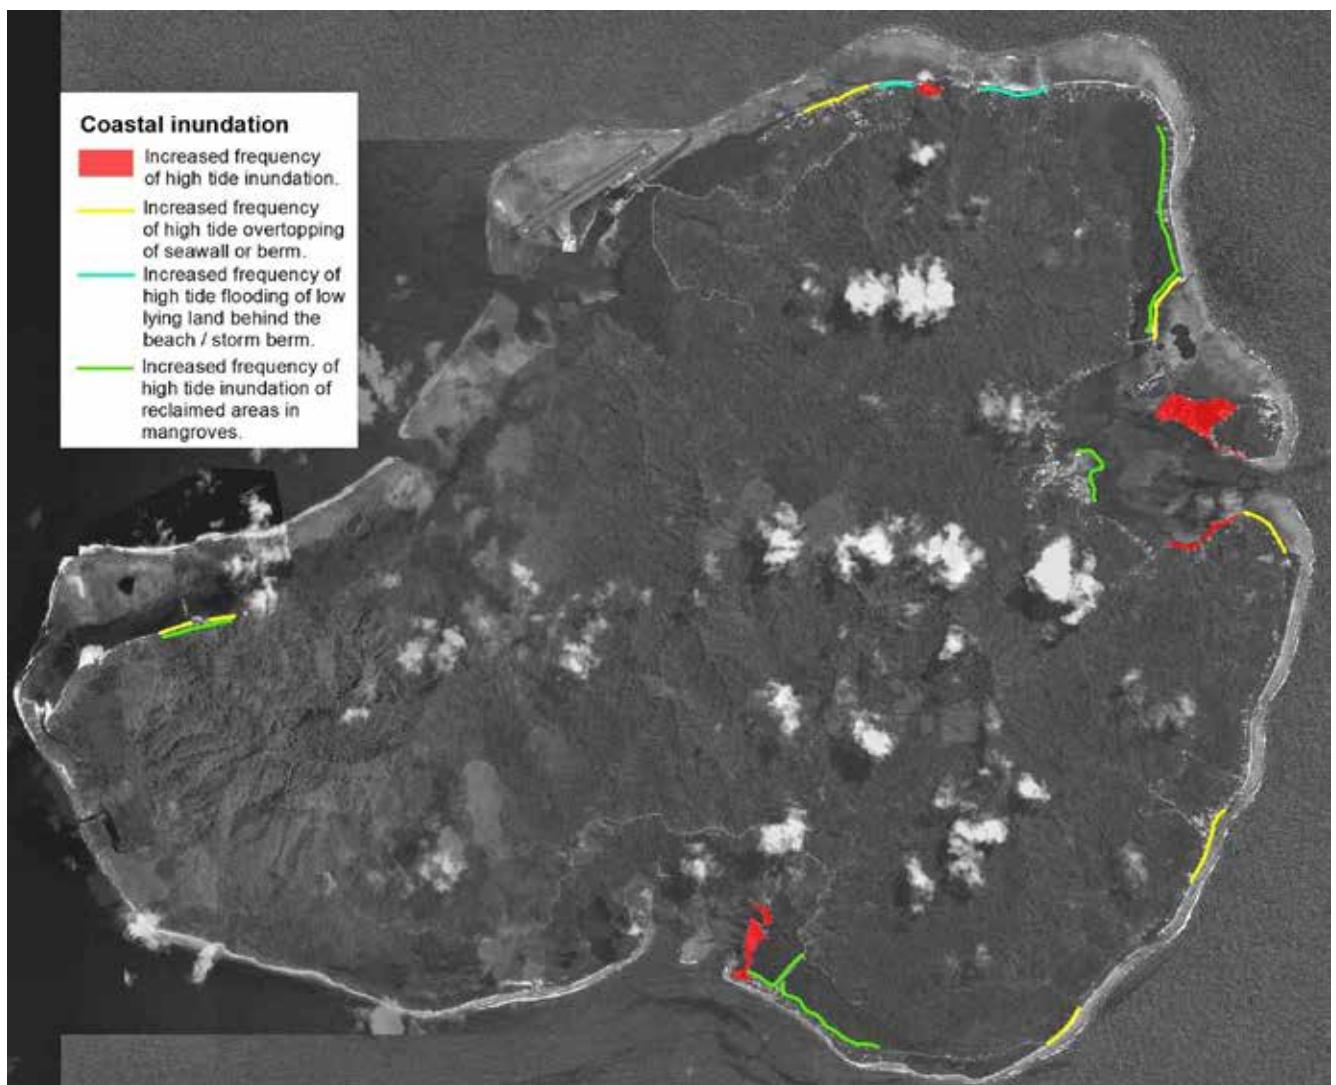
Figure 10: Summary of key locations where coastal inundation issues will increase on Kosrae over the next one to two generations.

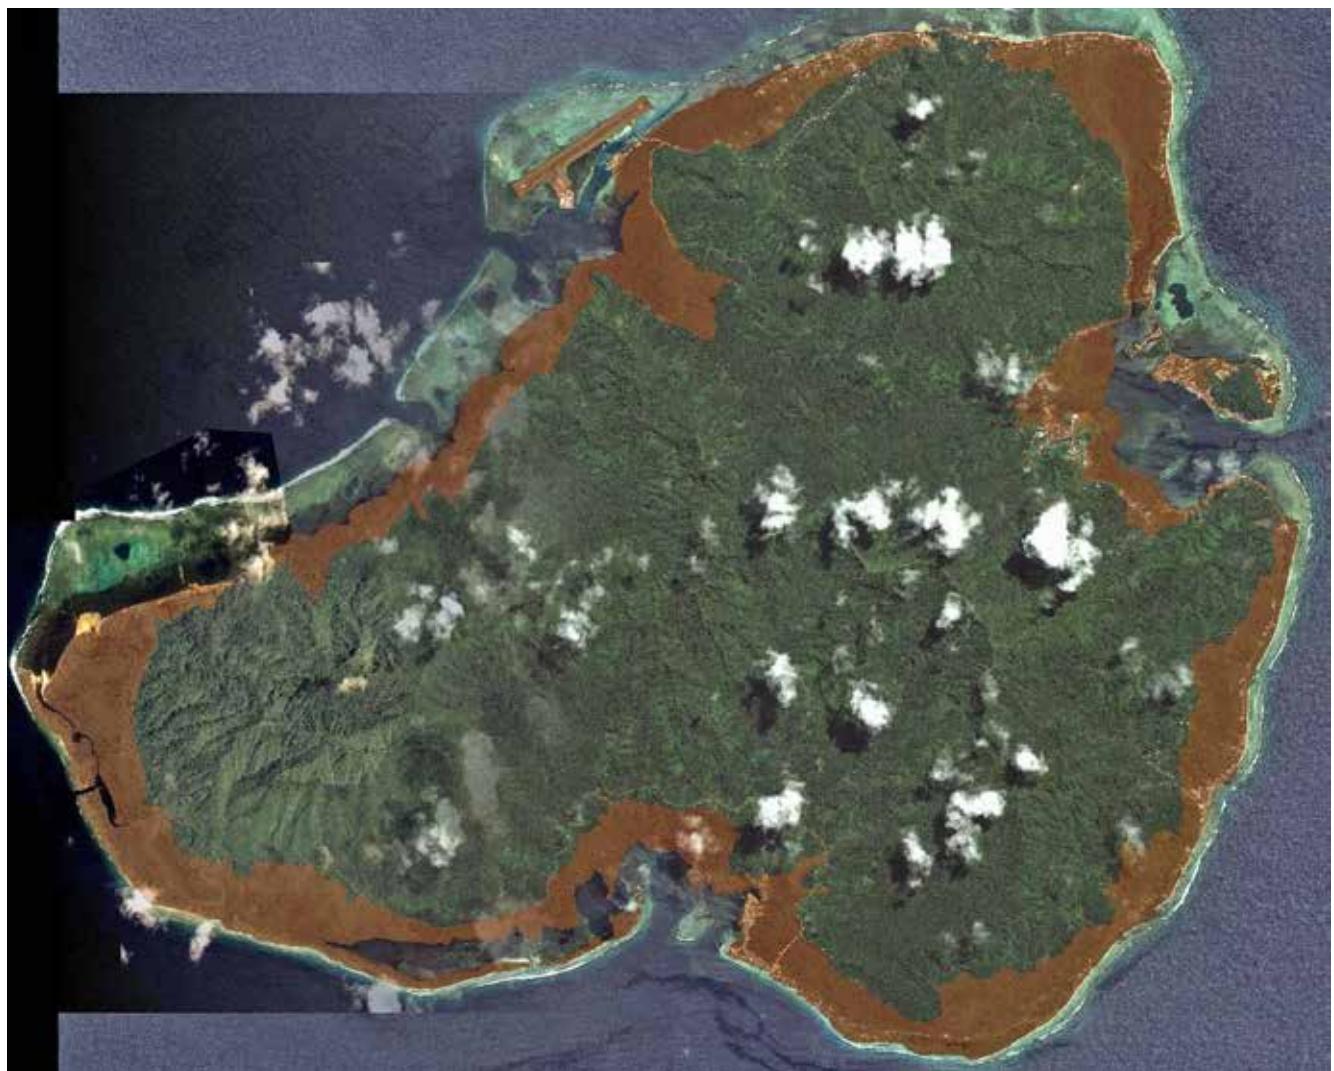
Figure 12: Low-lying coastal areas where restrictions on further development are required. The areas shown in red are largely below the 4 m MSL contour which is approximately 2 m above present day high spring tide level.

The area covered by the above development restrictions is shown in Figure 12.

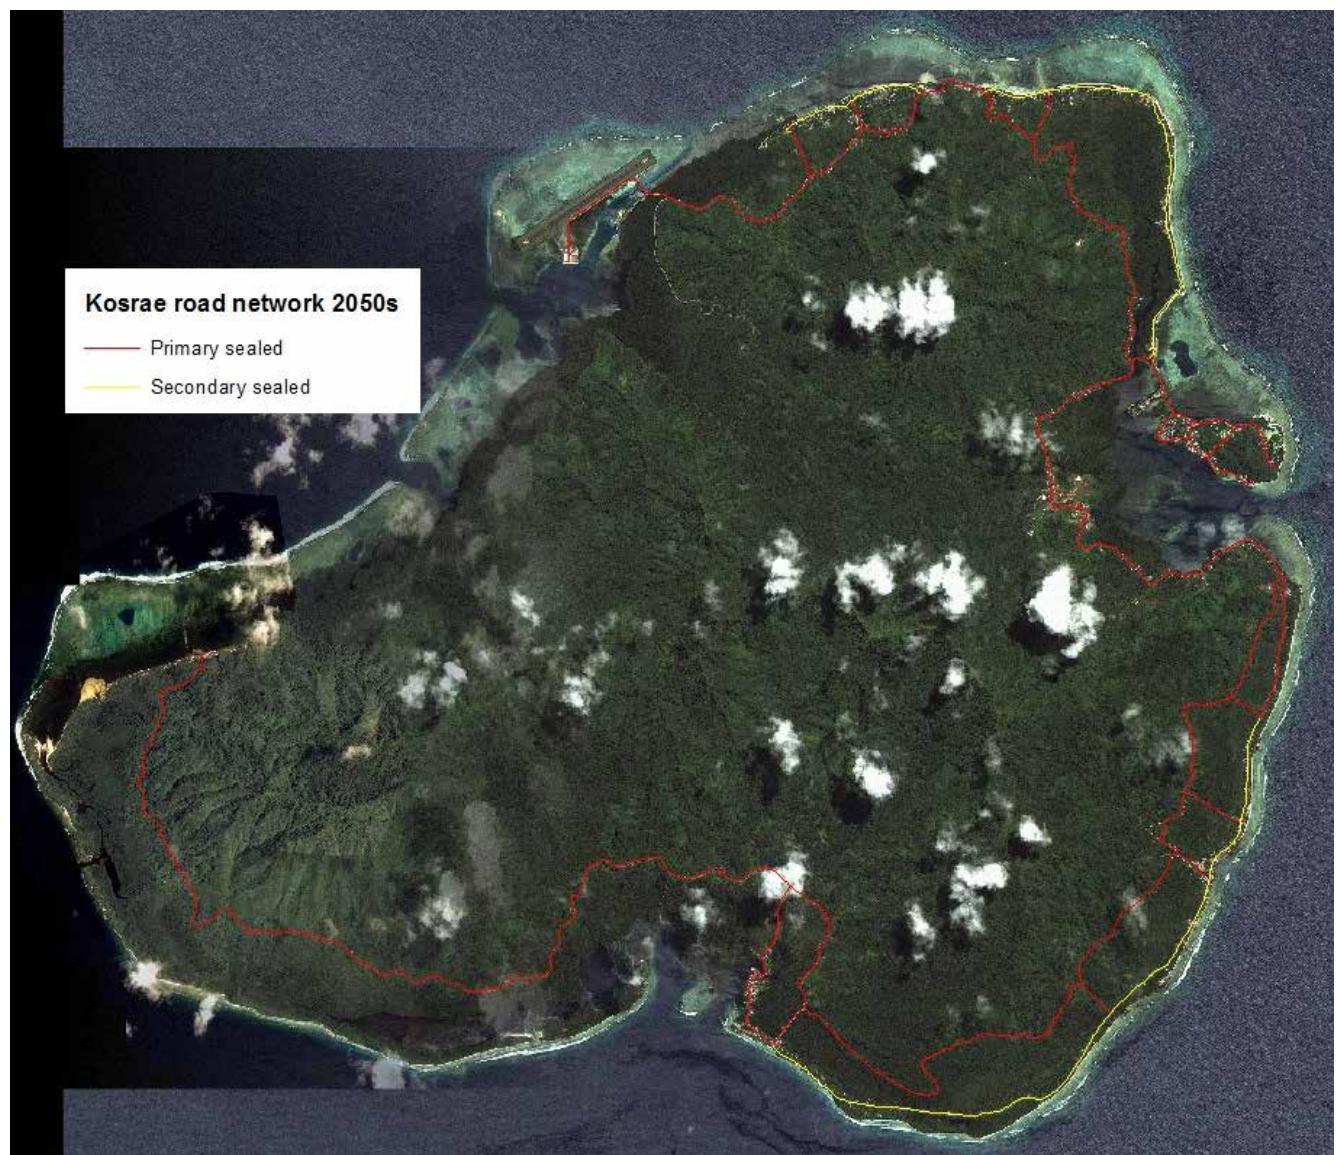
Figure 13: Potential primary and secondary sealed road network on Kosrae by the 2050s. Note: Parts of the secondary road network (current coastal road) may become impassable due to ongoing shoreline change and breaching.

By the 2050s (2 generations time) Kosrae needs to have made significant progress in implementing an adaptation strategy that repositions the majority of existing critical infrastructure and property away from the beach/storm berm areas, reclaimed areas of mangrove and low-lying wetland swamp to slightly higher ground around the base of the volcanic part of the island (Figure 13).

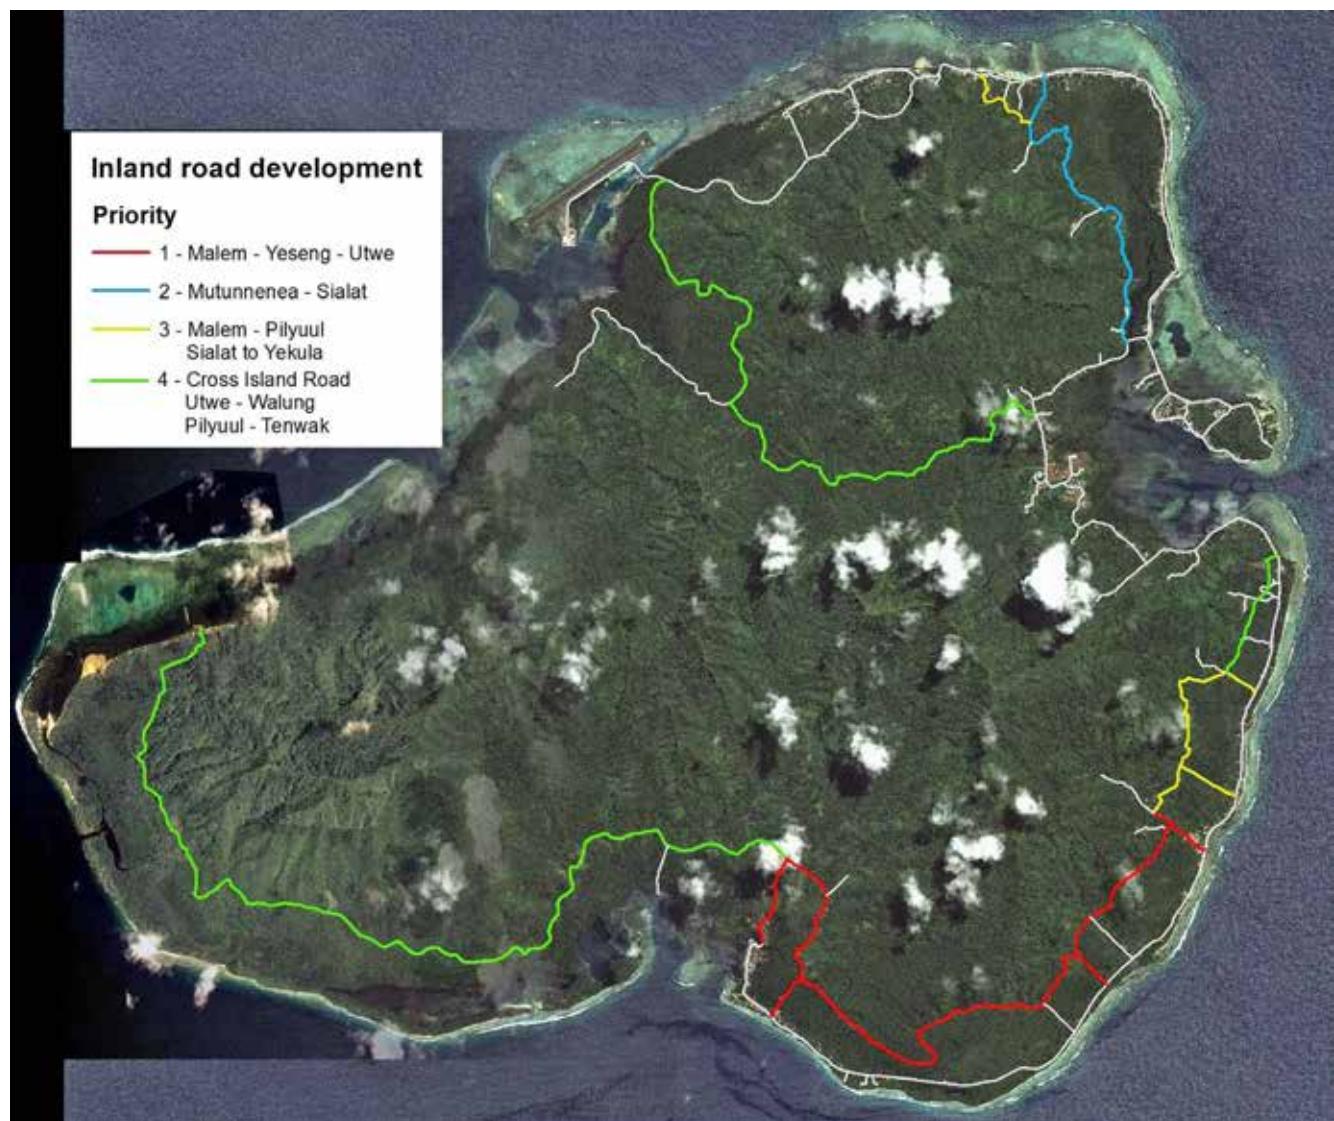
Figure 14: Priority section of the development of the inland road on Kosrae.

The prioritized redevelopment of the coastal road is summarized in Figure 14 and outlined below:

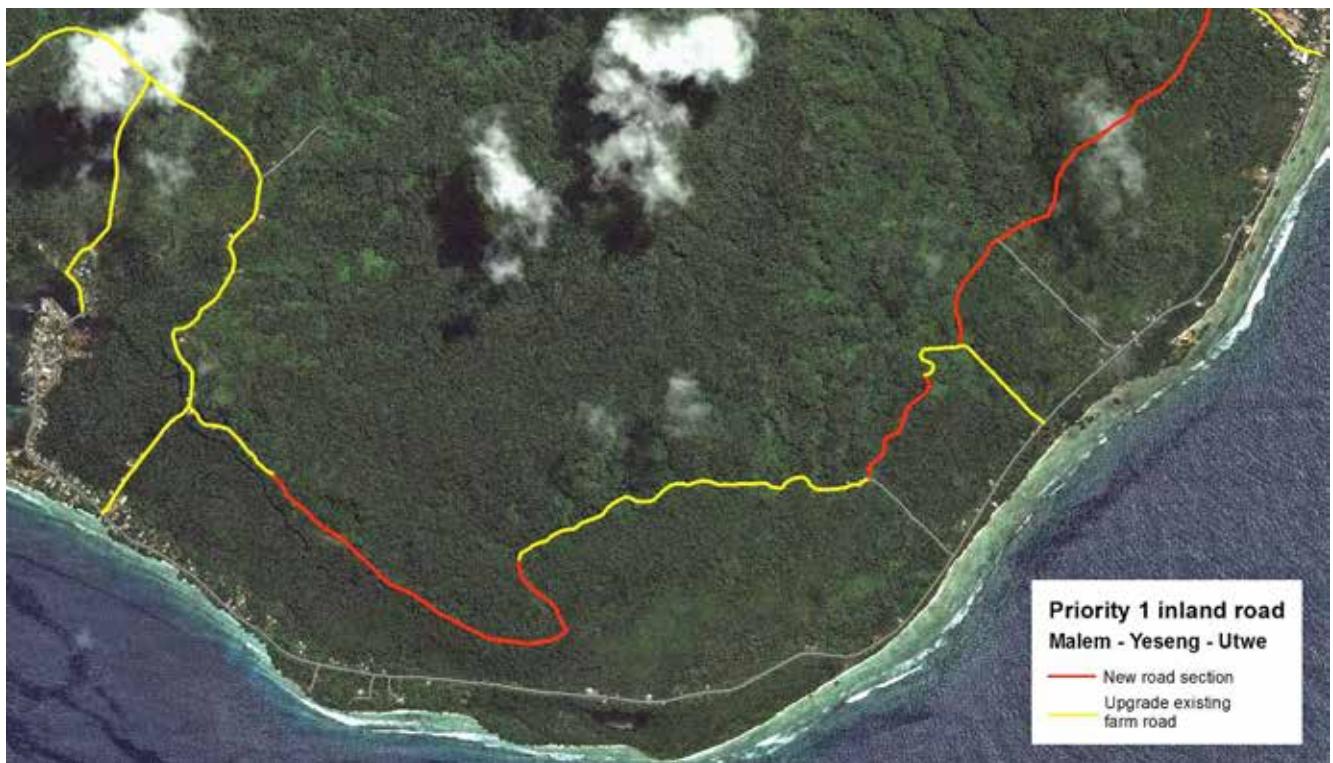
Figure 15: Indicative inland road between Utwe and Malem showing the requirements of new and upgraded sections of road.

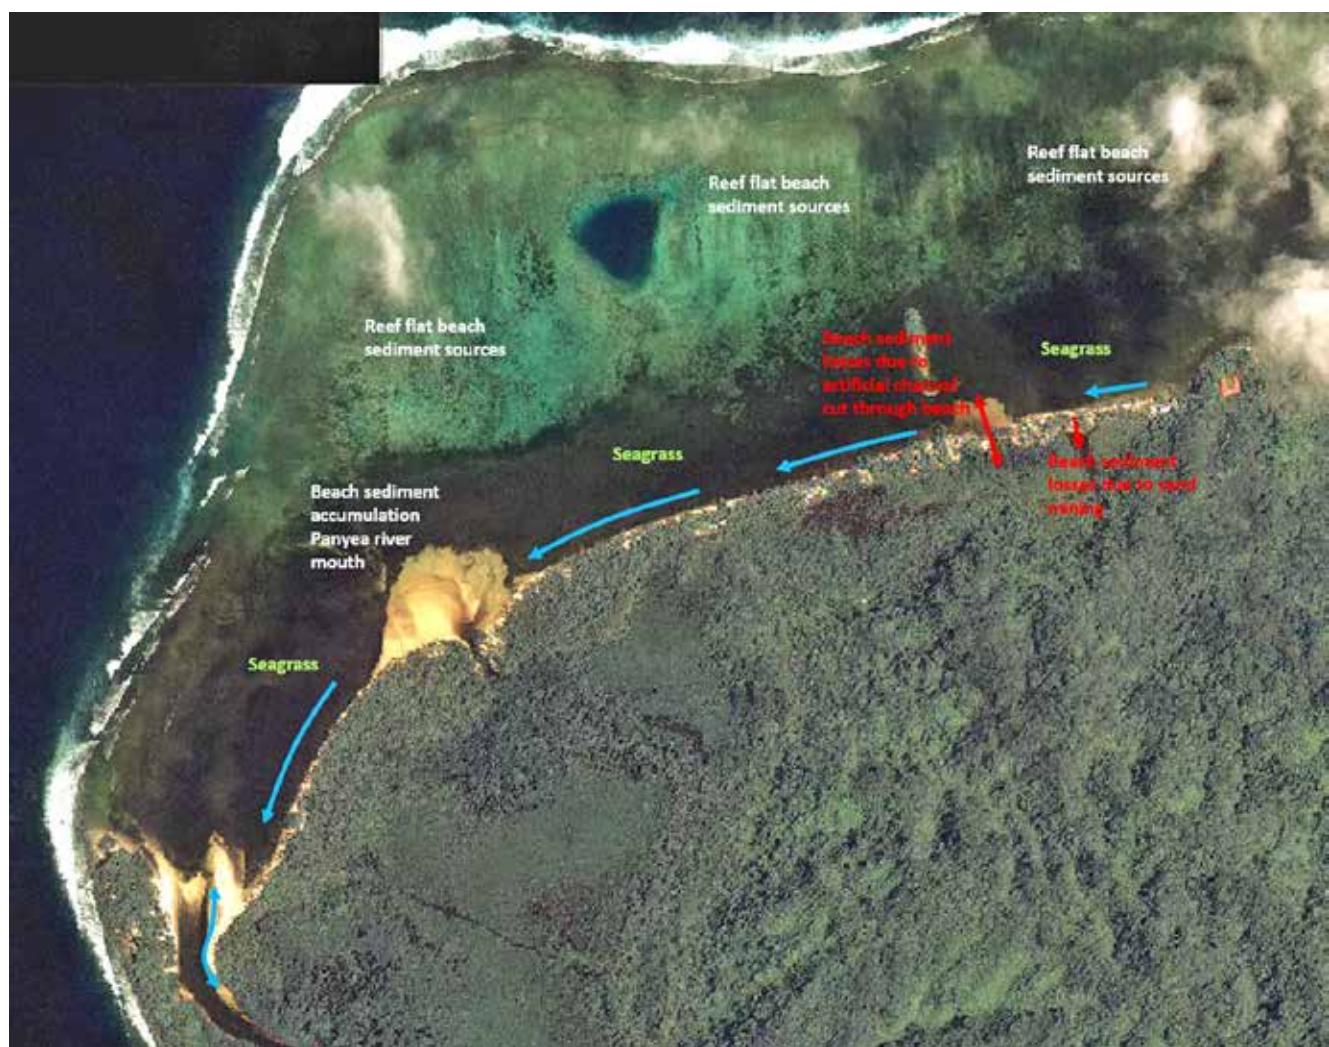
Figure B 4: Key sediment sources, longshore transport processes, and sediment losses along the Walung shoreline.

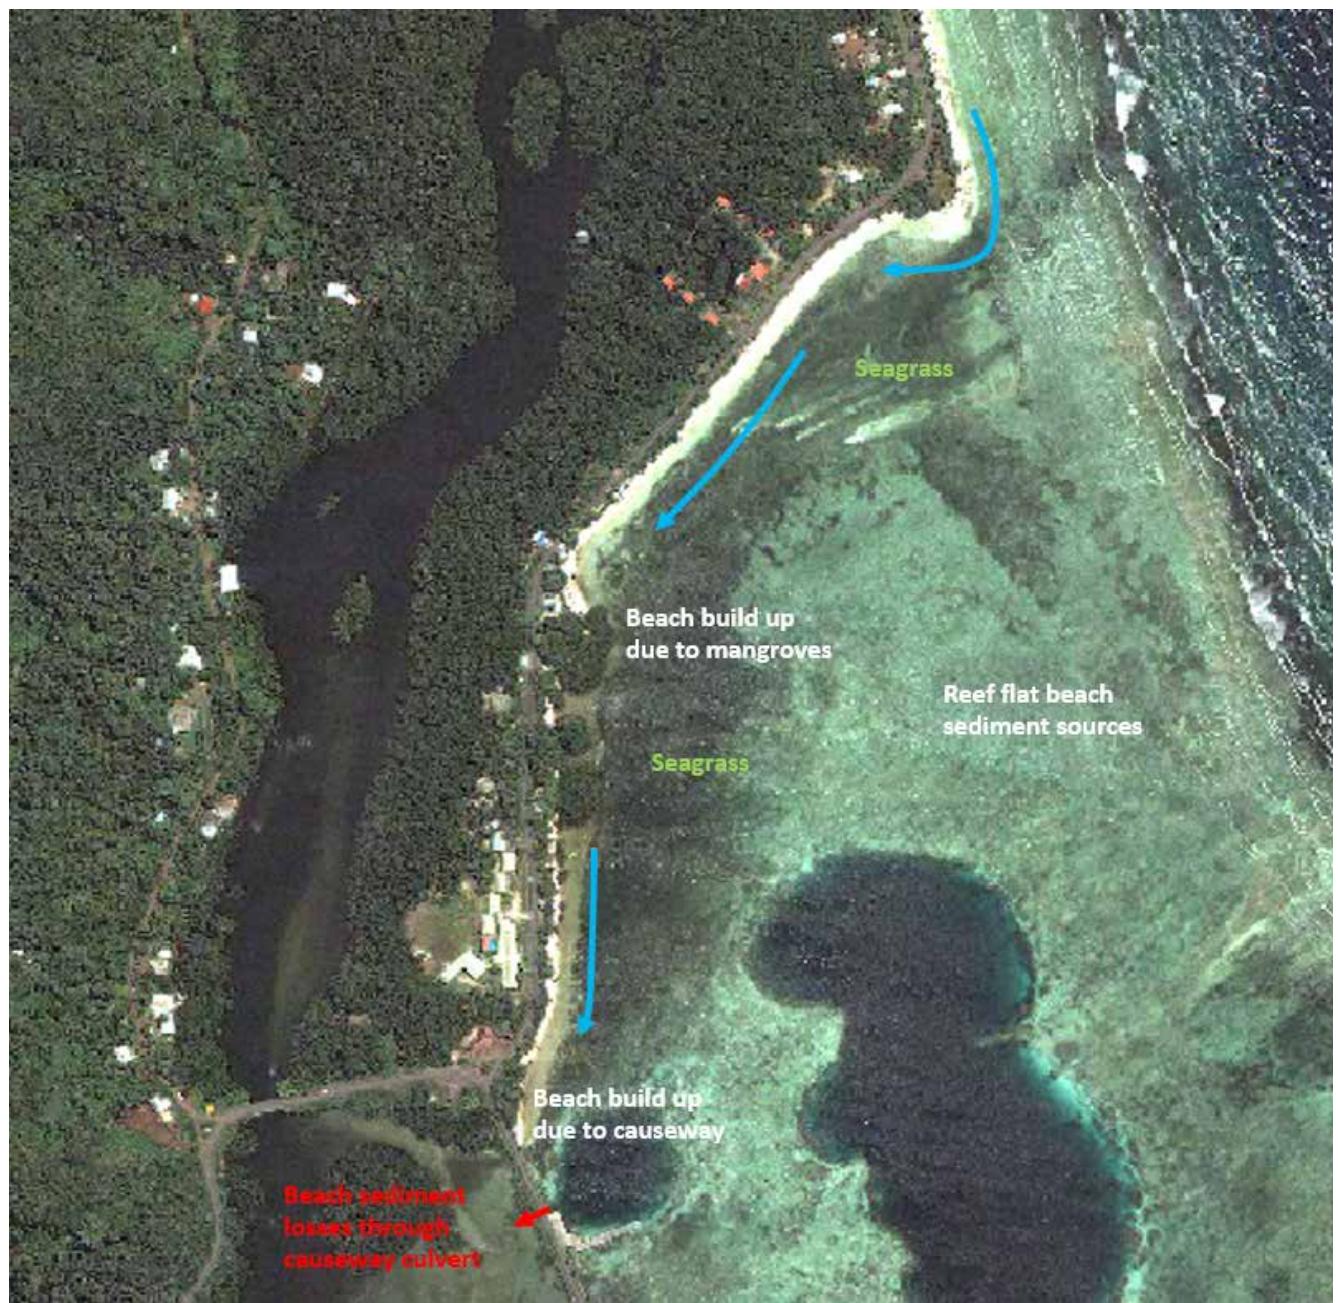
Figure B 5: Key sediment sources, longshore transport processes, and sediment losses along the Putukte to Finpukal shoreline.

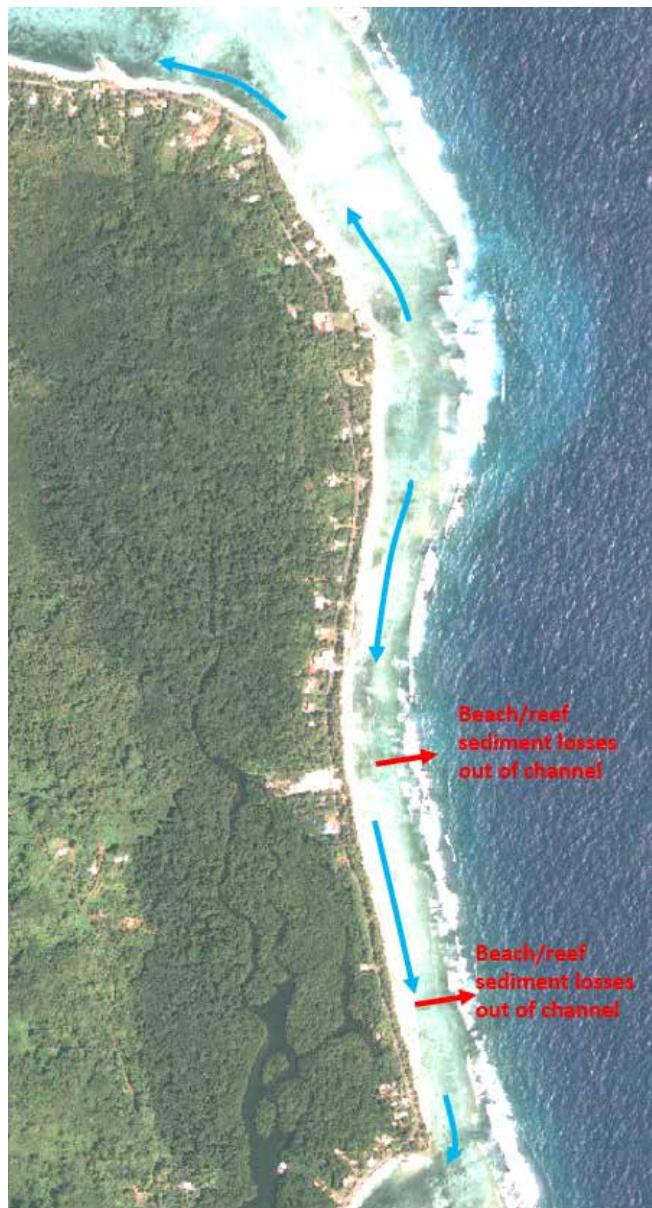
Figure B 10: Key sediment sources, longshore transport processes, and sediment losses along the Pukusruk shoreline.

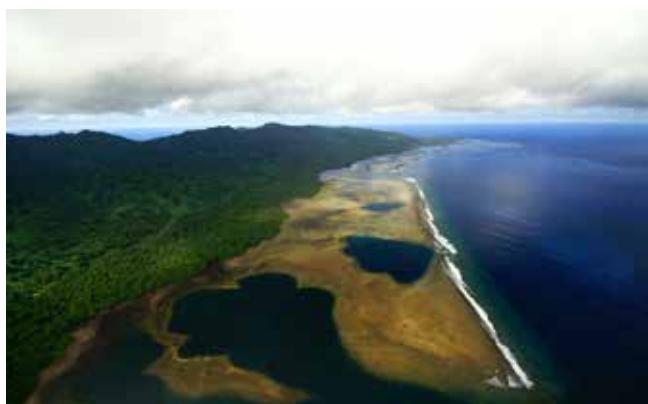
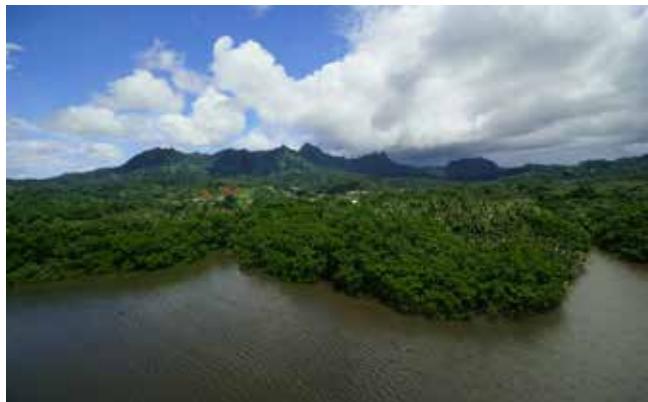
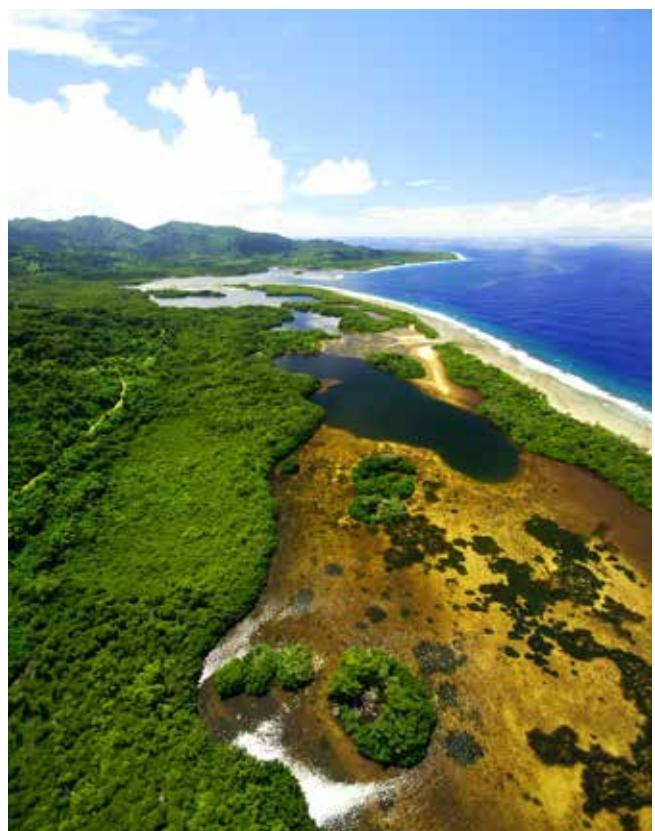
Figure B 12: Key mangrove settings on Kosrae. Top left: reef flat mangroves between Okat and Yela; Bottom left: Fringing harbour mangroves in Lelu Harbour at Tofol; Right: Back lagoon mangroves between Nefalil and Utwe Ma.

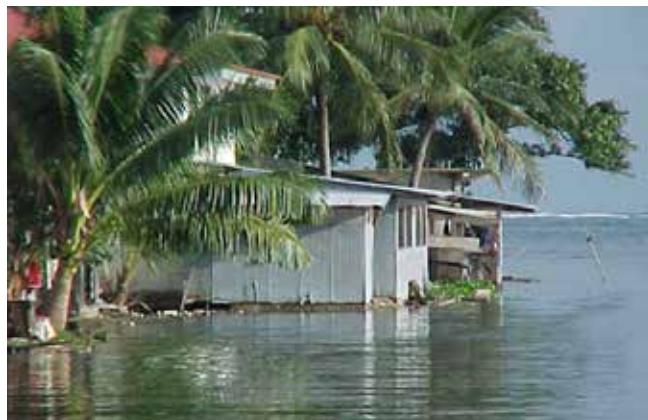
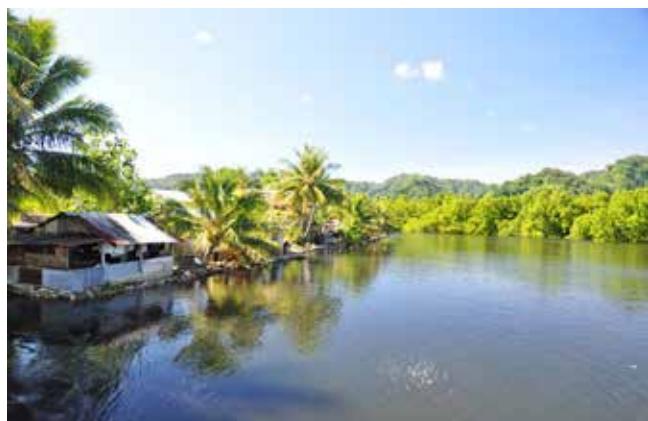
Figure C 1: High tide levels at Lelu during December 1999 (left) and Utwe during December 2010 (right).

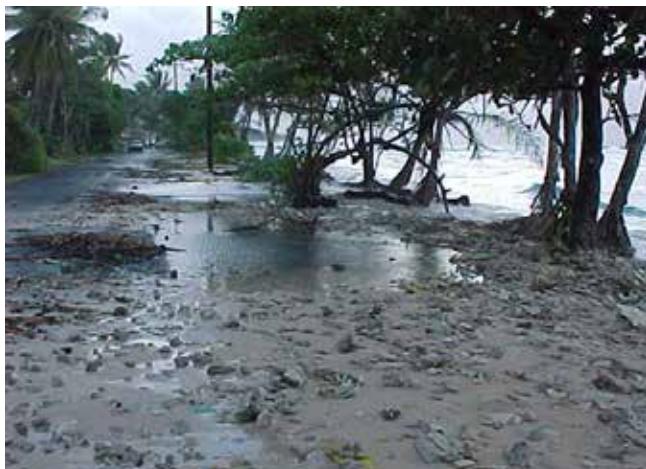
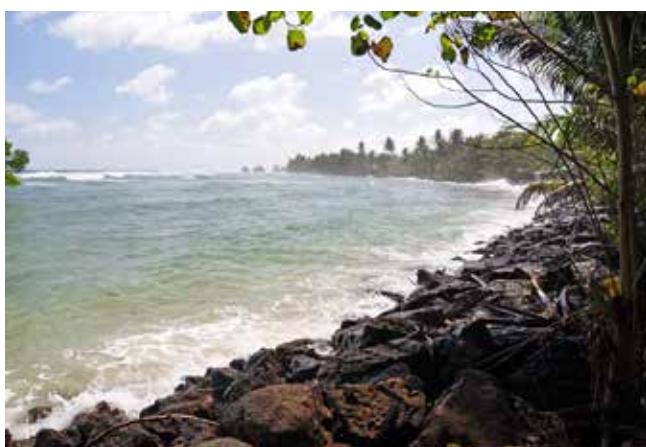
Figure C 2: Wave overwashing at Fukrin in Malem during February 2000 (left) and high tide wave overtopping of the seawall at Malem village during December 2010.

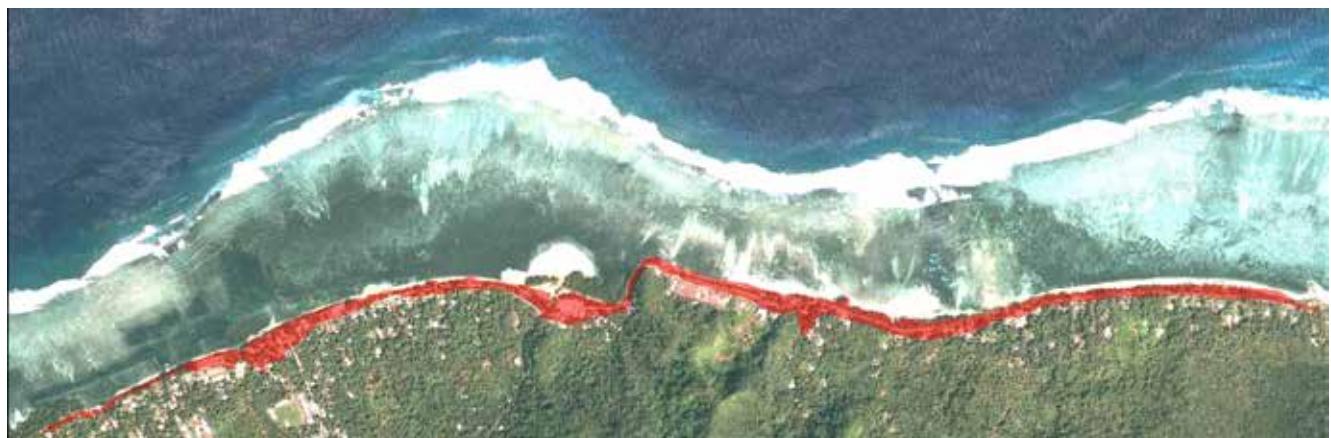
Figure C 4: Extent of inundation along the Tafunsak coastline during the swell event of 8-9 December 2008. Inundation extent information courtesy of KIRMA.
